Manhole Inspection Summary

Manhole # S35II_053MH

Insp Date: **3/12/07 1:32 PM**

Location Address: **1700 LANVALE ST**

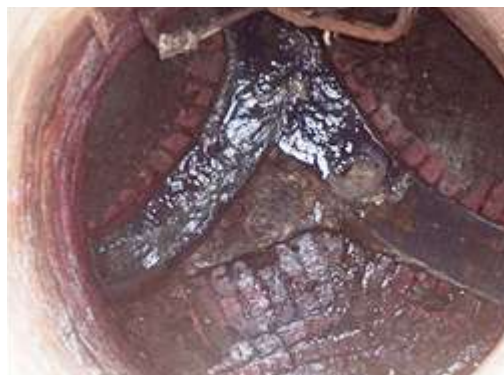
Top View

Corroded and missing steps. Evidence of surcharge - Bench debris.

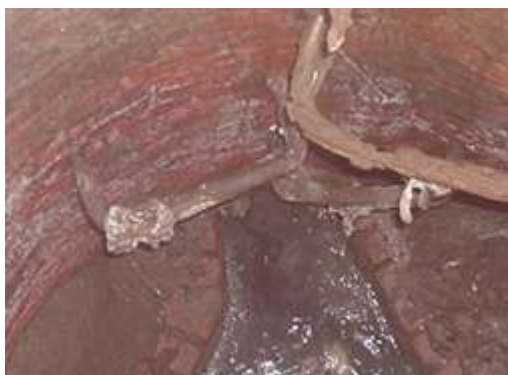
Defect

Evidence of surcharge - Bench debris.

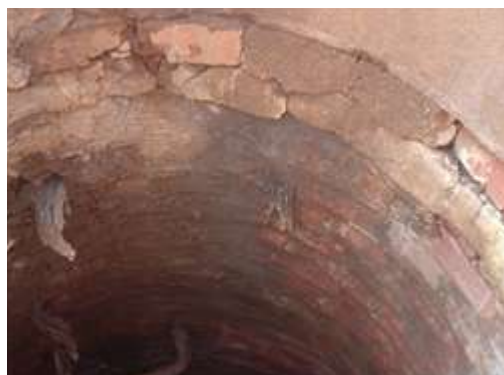
Defect

Frame leaks. Adjustment deterioration, loose brick and infiltration. Corroded and missing steps.

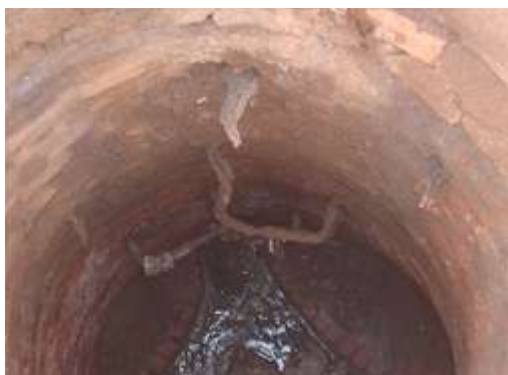
Defect

Frame leaks. Adjustment deterioration, loose brick and infiltration.

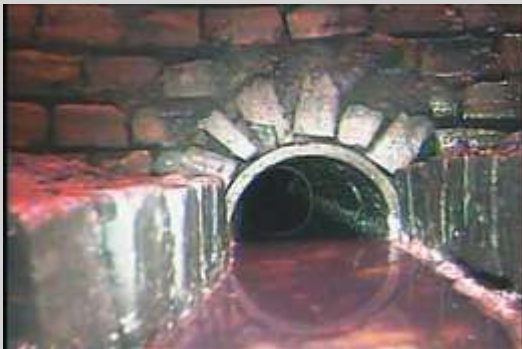
8 in. Circular Gravity Sewer Pipe In @ 4 O'Clock

Barrel deterioration and infiltration. Channel deterioration.

Deposits: ☐ None ☐ Mud ☐ Sludge ☐ Debris ☒ Grease

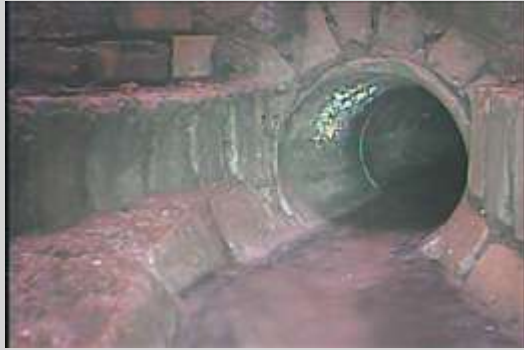
Pipe In @ 8 O'Clock

Deposits: ☐ None ☐ Mud ☐ Sludge ☐ Debris ☒ **Grease**
